## Longevity of the effectiveness of interim soil lead hazard control measures and influencing factors

C. Scott Clark<sup>a,\*</sup>, Paul A. Succop<sup>a</sup>, William Menrath<sup>a</sup>, Sandy M. Roda<sup>a</sup>, Stuart Greenberg<sup>b</sup>, Mia Buchwald-Gelles<sup>b</sup>, Hongying Peng<sup>a</sup>

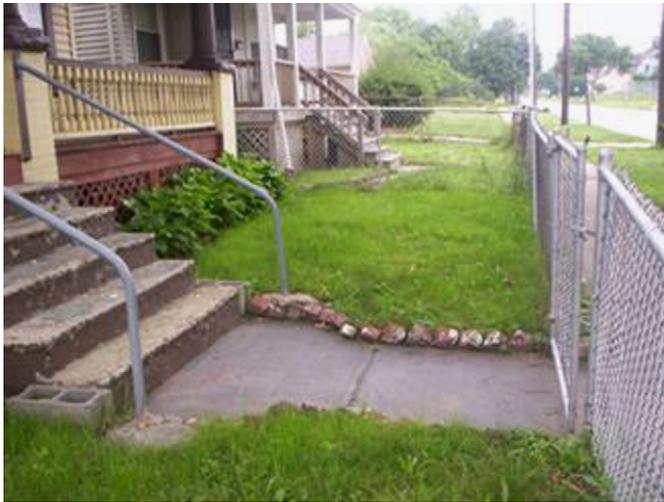
**Fig. 1.** Photo of re-seeded soil areas without visual failure.

Fig. 1 is a photo of soil area where the soil area that was re-seeded is shown to have grass that now fully covers the area and was judged to have no visual evidence of treatment failure. Fig. 2 is a photo of an area behind a garage where only 15 of 300 ft<sup>2</sup> of area treated by use of mulch/wood chips was judged to not show visible failure. The light areas are plastic sheeting that was placed under the mulch/wood chips at the time of the intervention. Just in front of the cinderblock divider a small amount of bare soil (estimated 15 ft<sup>2</sup> out of 1200 ft<sup>2</sup> treated by

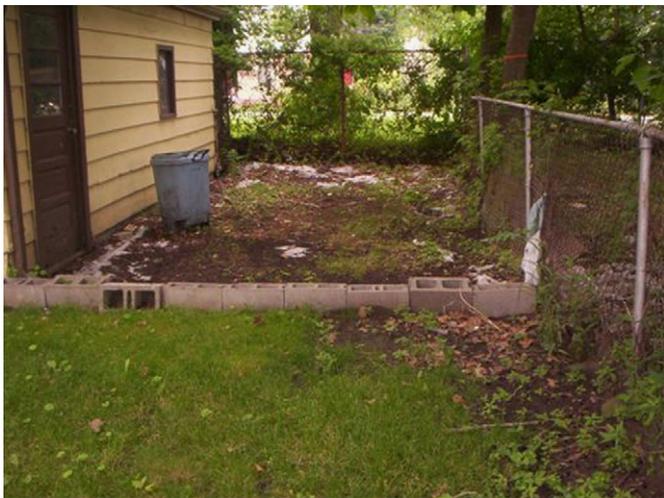
**Fig. 2.** Photo of mulch/wood chip treatment with high percentage of failure and re-seeded area with minimal failure.

re-seeding). Only 1 subsample was collected from this area for the failed composite sample for this house.
